CHINA PIVOT SOURCING CO.,LTD

EXECUTIVE SUMMARY

To:	John
Attn.:	John
Product Name	coffee scoop
Vendor/Supplier:	Reason Enterprise Co., LTD.
Factory Name:	Reason Enterprise Co., LTD.
Factory Contact:	Rita Lin
Insp. Location:	Yang jiang.Guangdong
Inspection date:	July 05,2016
Time of insp.:	1st ☒ 2nd ☐ 3rd ☐

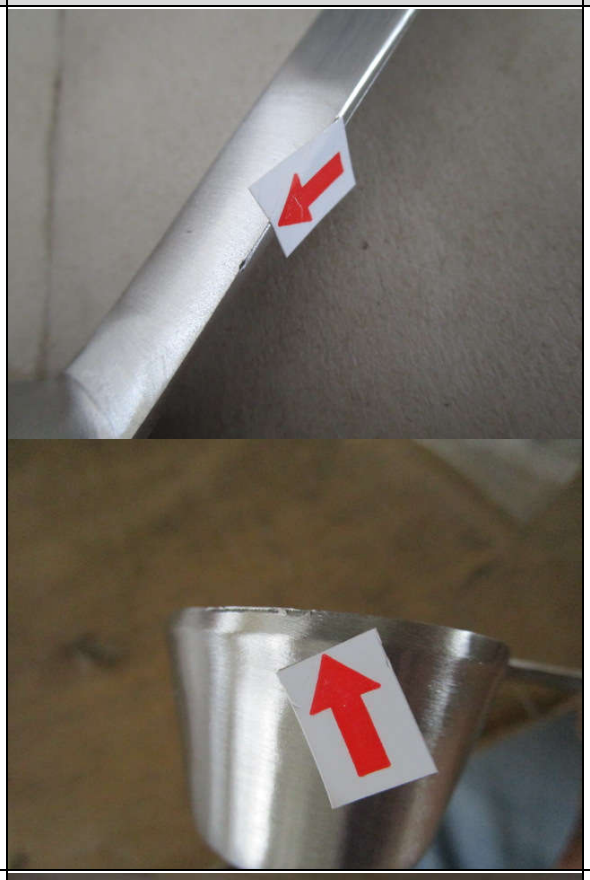
No.	Defects Description	Picture	CRI	MAJ	MIN
1	defect-major-chipped edge

0	2	0
2	defect-major-obvious dent mark		0	4	0

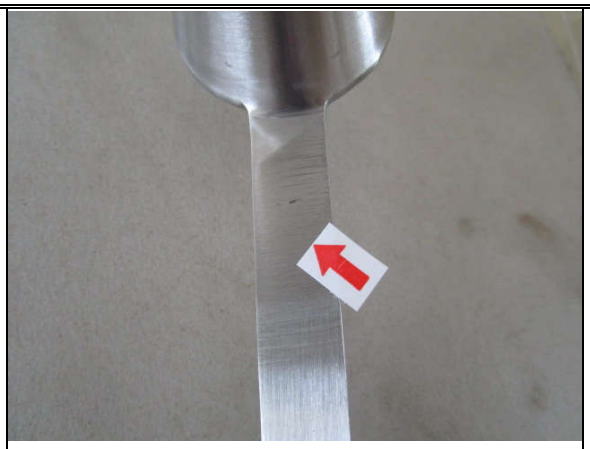
3	defect-minor-poor polishing		0	0	7

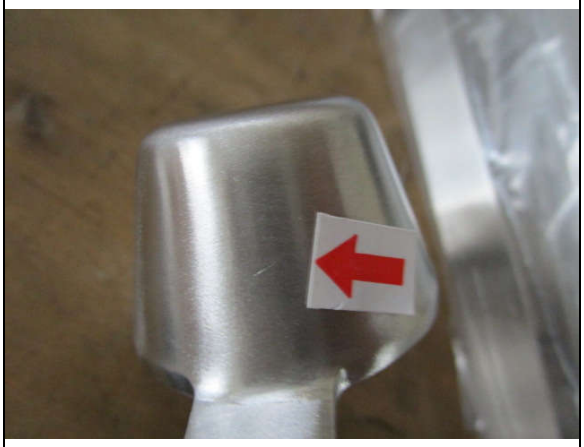
4.	defect-minor-scratch mark

0	0	2
		Total Defect Found	**0**	**6**	**9**

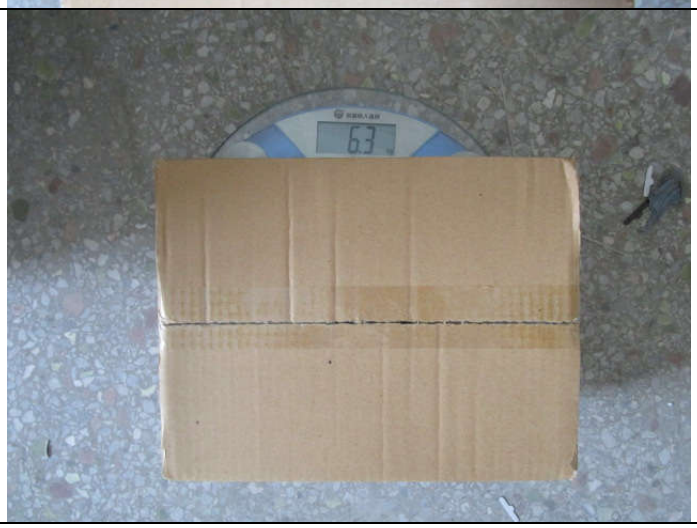
Carton weight check		13.3kg		
Inner box size check		300x235x110mm		
Inner box weight check

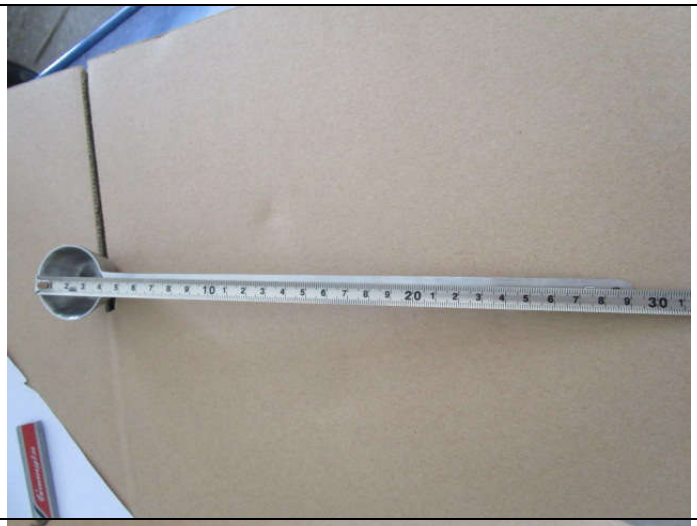
292mm		
Product size check		39.69mm		
Product size check		25.39mm

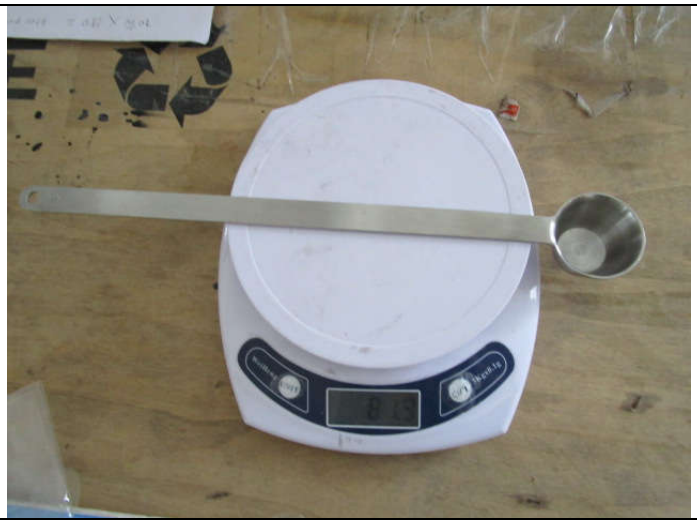
Product weight

819g

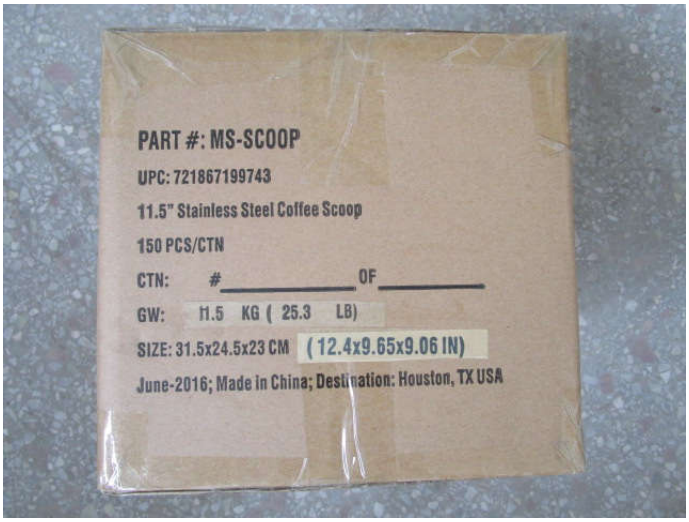
The 4 cartons for airfreight has no shipping label sticker

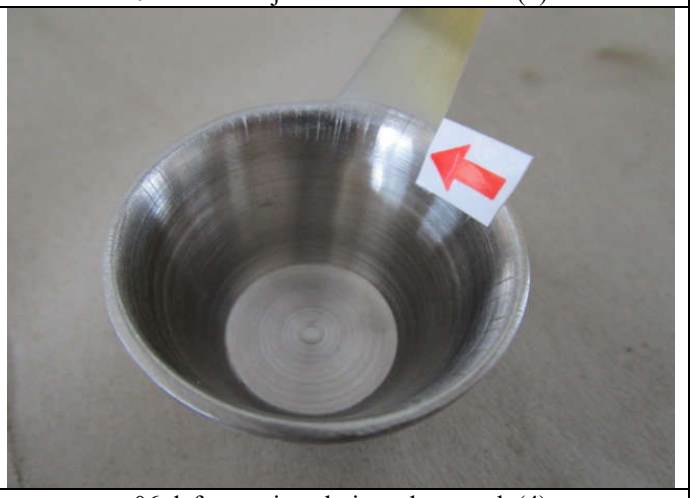
04 defects pictures	
01 defect-major-chipped edge (1)	02 defect-major-chipped edge (2)
03 defect-major-obvious dent mark (1)	04 defect-major-obvious dent mark (2)

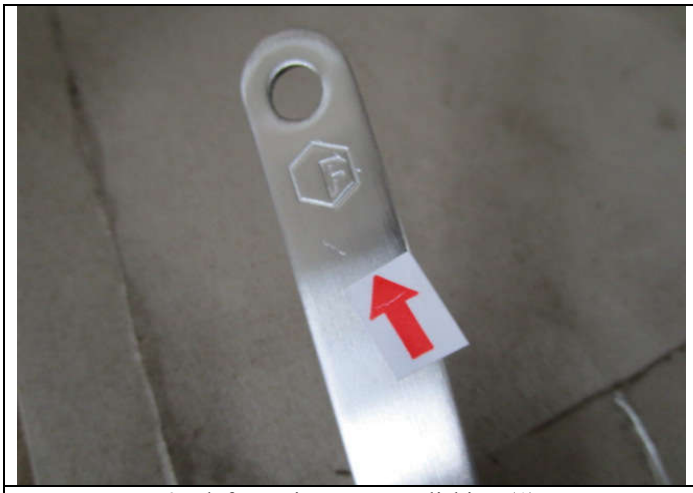
05 defect-major-obvious dent mark (3)	06 defect-major-obvious dent mark (4)

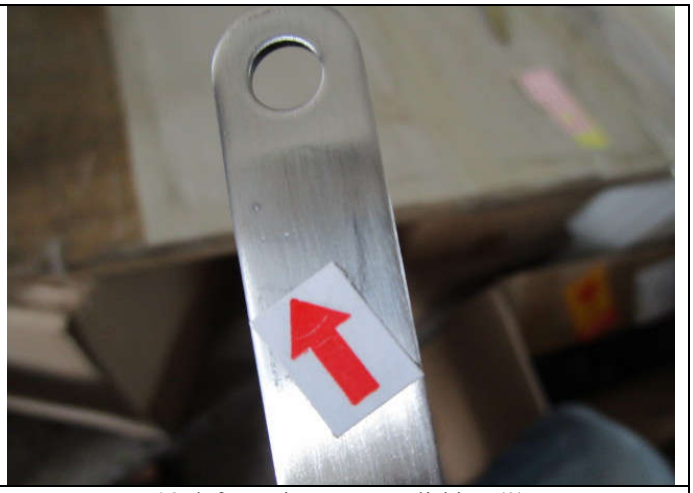
07 defect-minor-poor polishing (1)

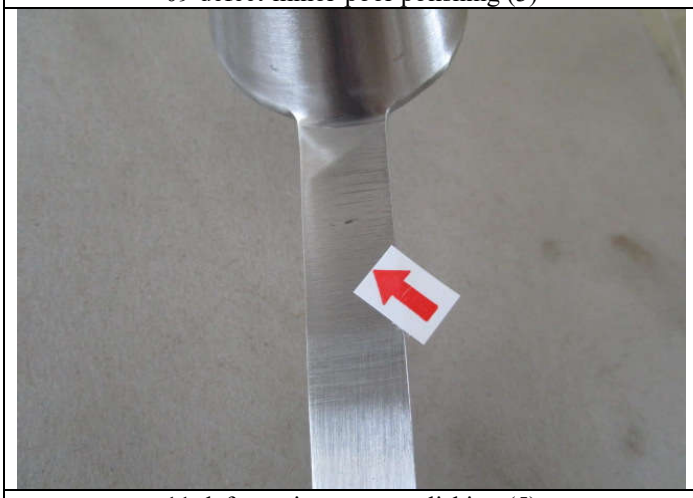
10 defect-minor-poor polishing (4)

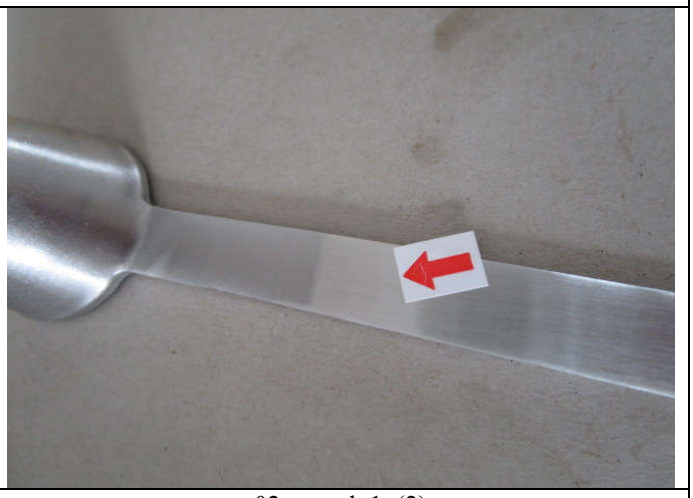
01 remark 1 (1)

1. For the handle back close to cup, the polishing line is vertical . Detail as below:
